Subject: Structural Foundation Inspection Report (Level B)  
Slab Foundation  
1708 Woodlawn Trail, Prosper, TX

1708 WOODLAWN TRAIL, PROSPER, TX

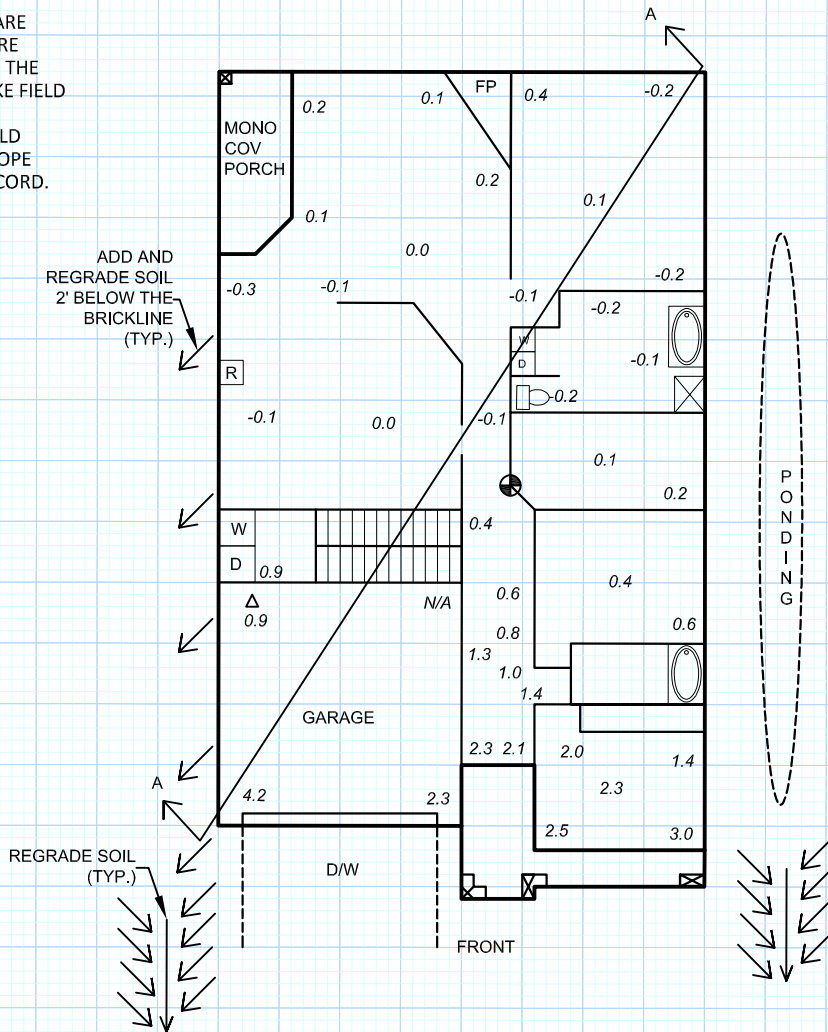
#### LIMITED REPAIR PLAN

This foundation has an overall deflection along section A-A that almost exceeds  $L/360$ . It is likely that a full underpin will be necessary to repair this foundation in the future. However, it does not fail overall deflection or tilt analysis currently.

- NO FOUNDATION REPAIRS RECOMMENDED ATR THIS TIME.
- REGRADE APPROXIMATELY 66 LF OF SOIL ON THE LEFT SIDE OF THE STRUCTURE TO 2" BELOW THE BREAKLINE.
- REGRADE APPROXIMATELY 30 LF OF SOIL ON THE FRONT TO PITCH WATER AWAY FROM FOUNDATION.
- ADD DOWNSPOUT EXTENSIONS TO THE CURRENT GUTTERING SYSTEM.
- THIS FOUNDATION HAS AN OVERALL DEFLECTION ALONG SECTION A-A THAT ALMOST EXCEEDS L/360. IT IS LIKELY THAT A FULL UNDERPIN WILL BE NECESSARY TO REPAIR THIS FOUNDATION IN THE FUTURE. HOWEVER, IT DOES NOT FAIL OVERALL DEFLECTION OR TILT ANALYSIS CURRENTLY.

We recommend regrading approximately 66 LF of soil on the left side of the structure to 2" below the brickline, regrading approximately 30 LF of soil on the front to pitch water away from foundation, and adding downspout extensions to the current guttering system.
