Stucco Inspection Report

1114 Randolph Dr
Yardley, PA 19067

The subject property located at 1114 Randolph Dr was inspected, thermal scanned, and tested on: 10/19/2020 for: proper stucco installation detail, maintenance details, substrate rigidity, dampness or failure. The Moisture readings were taken in areas where substrate failure is most likely to occur. These readings were taken with a Delmhorst BD-2100 moisture meter through 1/4" probe holes which were drilled through the stucco and into the substrate wood (sheathing or studs as appropriate). These readings provide information about the condition of the substrate tested, and evaluation of the measurements is further outlined below. It is important to note that all observations and moisture readings represent the conditions present at the time of the inspection. Additionally, the structure was evaluated for confirmation of current installation details. It is important to note that codes have been updated over the years, and homes built prior to 2003 were constructed under a different set of codes and standards. This report is for the sole use of the person it was prepared for. It should not be used or relied upon by any other

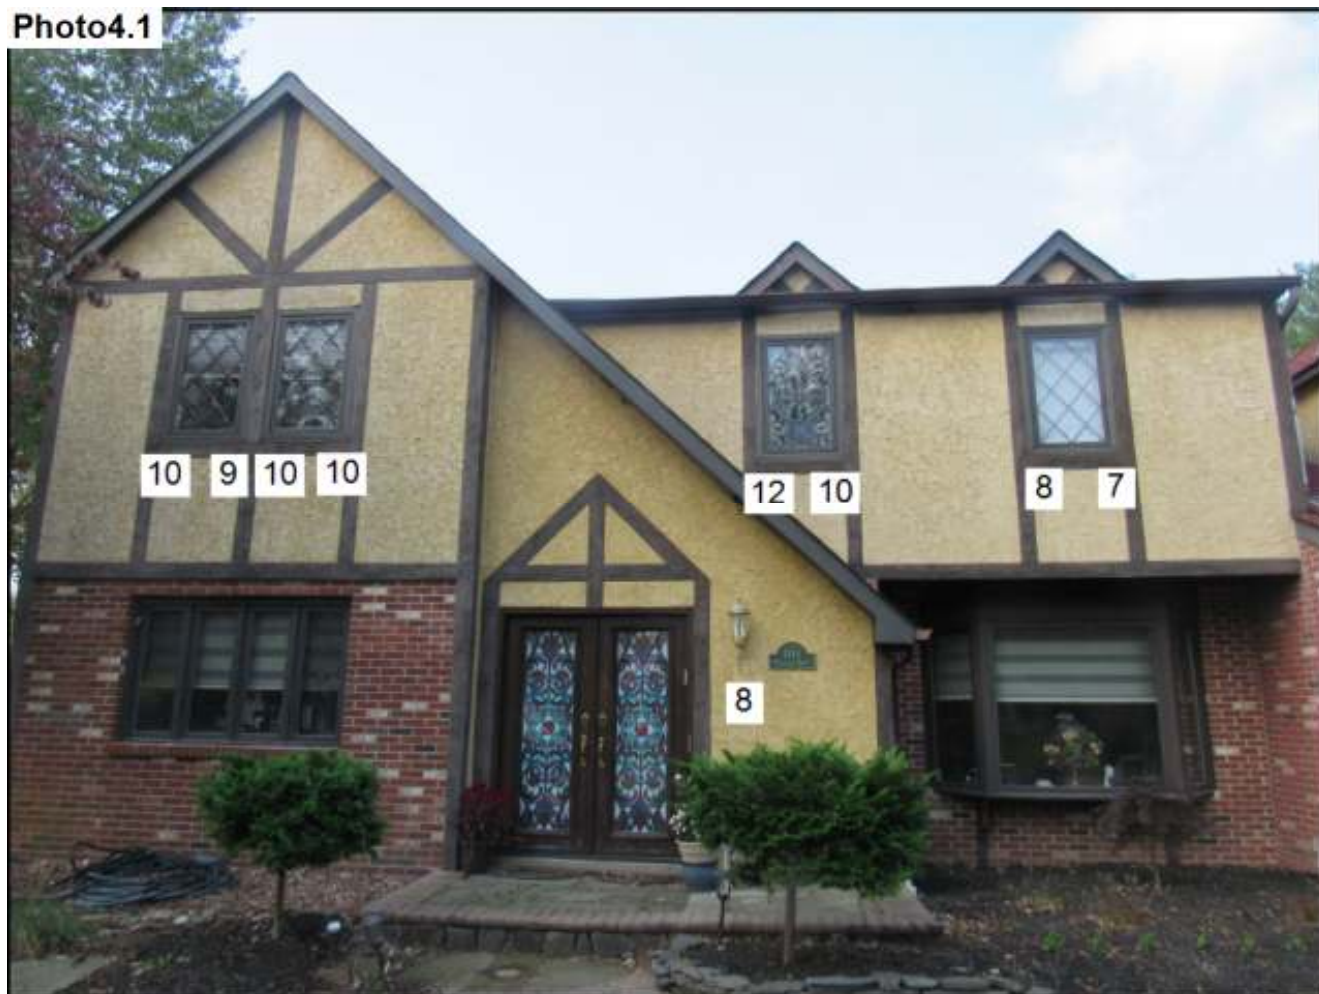
Photo4.1

Item	Item Description	Applies to Entire Bldg	Observations / Comments
	General		No Elevated moisture readings measured on this elevation.
	Weepscreed		Weepscreed was not present.
	Soft Joints/Caulk Details		Soft joints were not installed.

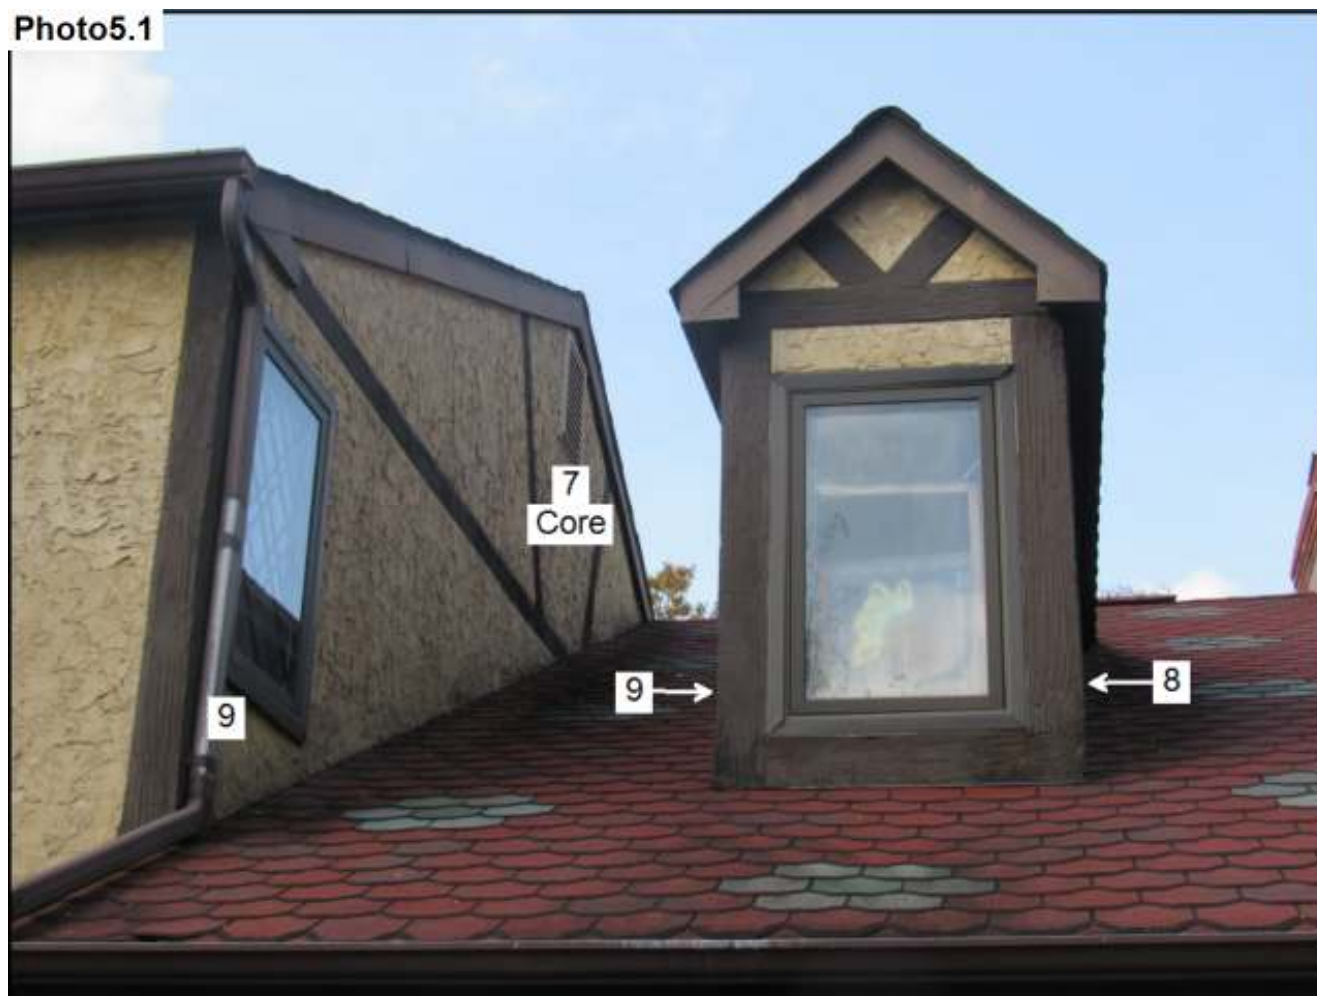
Photo5.1

Item	Item Description	Applies to Entire Bldg	Observations / Comments
	General		No Elevated moisture readings were measured on this elevation.
	Weepscreed		Weepscreed was not present.
	Soft Joints/Caulk Details		Soft joints were installed.
	Core		Core revealed T-ply substrate over dry wood framing.

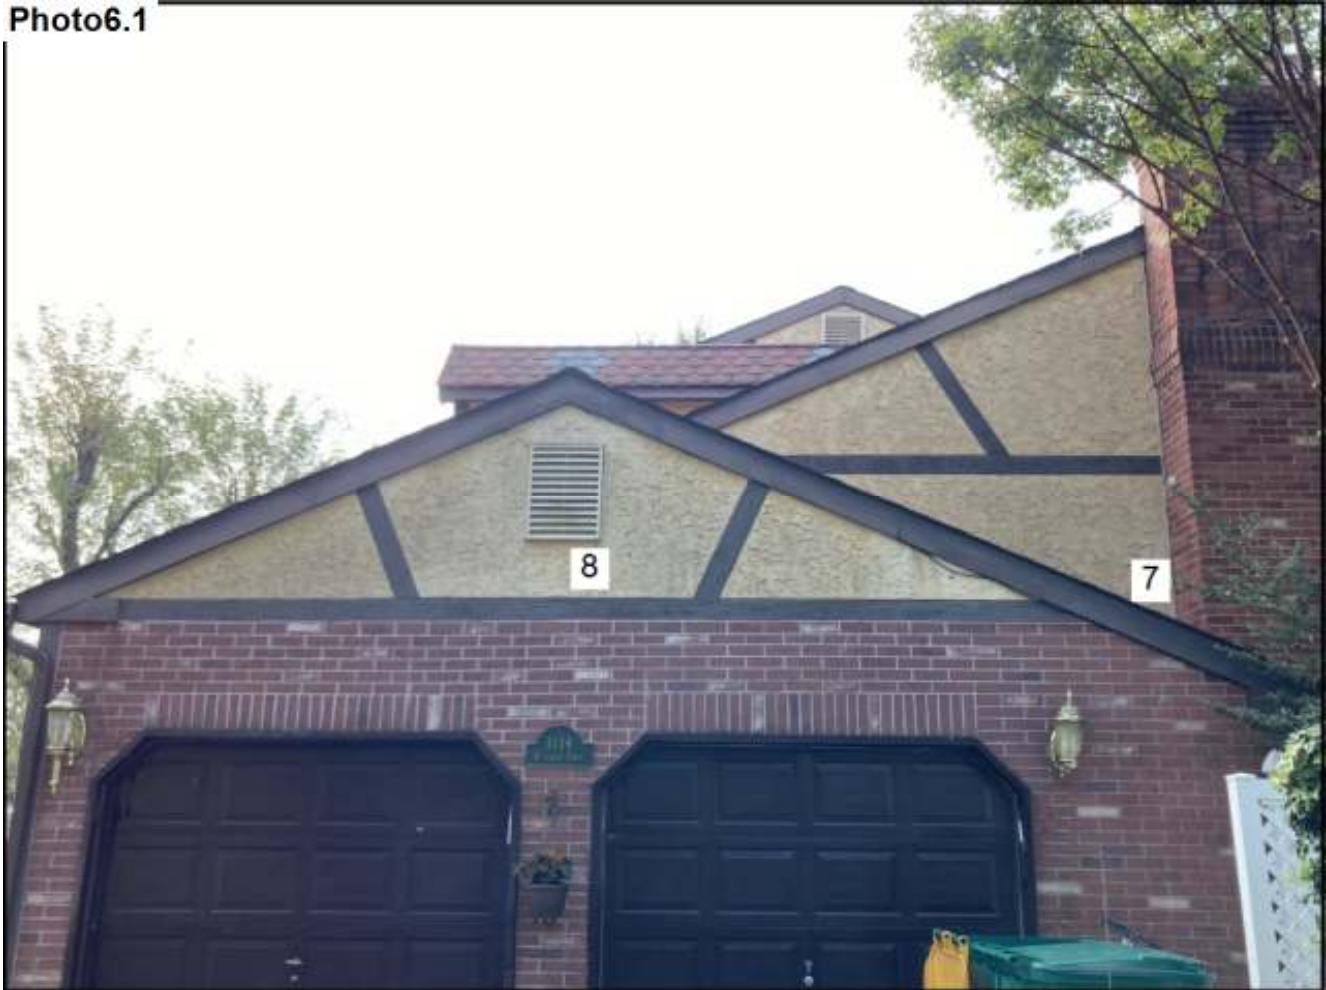
Photo6.1

Item	Item Description	Applies to Entire Bldg	Observations / Comments
	General		No Elevated moisture readings measured on this elevation.
	Weepscreed		Weepscreed was not present.
	Soft Joints/Caulk Details		Soft joints were not installed.

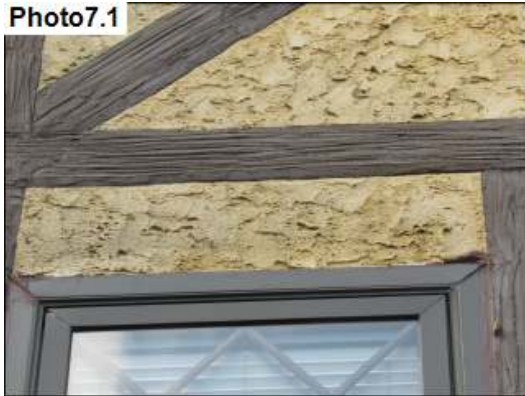
Photo7.1

5. Head Flashing - Head flashing was not installed on the windows and doors. The purpose of a head flashing above a window or door is to allow moisture to escape and prevent potential pockets of high moisture concentration around the windows.

Head flashing was not installed on the windows and doors.

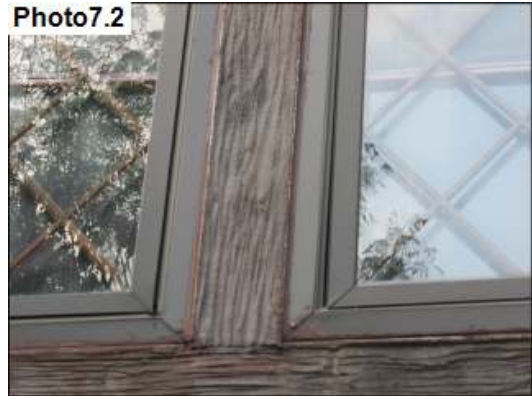
Photo7.2

Soft joints were installed around windows and doors.

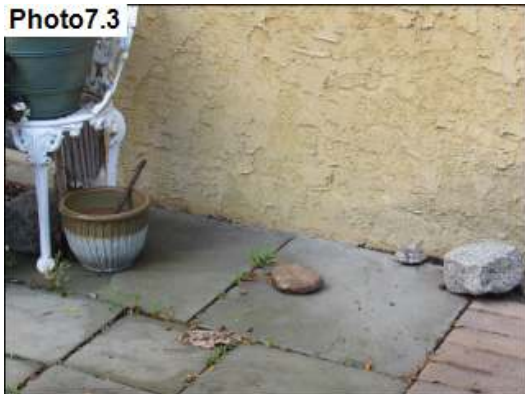
Photo7.3

Termination to slab is improper. Should have 2" gap.

5. Clear mulch and landscaping as needed, so that there is a minimum 4" gap between the top of the landscape surface and the bottom of the stucco

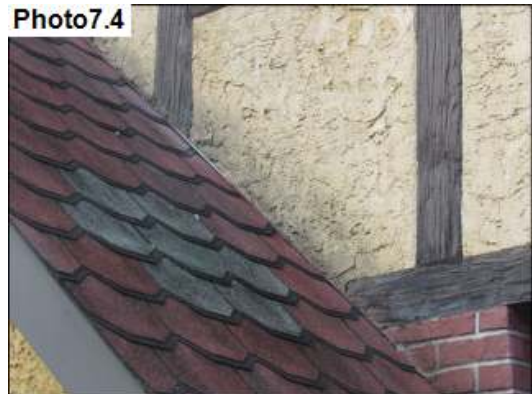
Photo7.4

4. Termination to Roof - The roof termination is improper on this home. Industry standards require a 2" separation between the roof shingles and the stucco and/or stone cladding. There should also be an integral weep system at the base of the adhered stucco/stone system. The stucco system should not be in contact w/ roof covering.

Termination to roof is improper. Should have 2" gap.

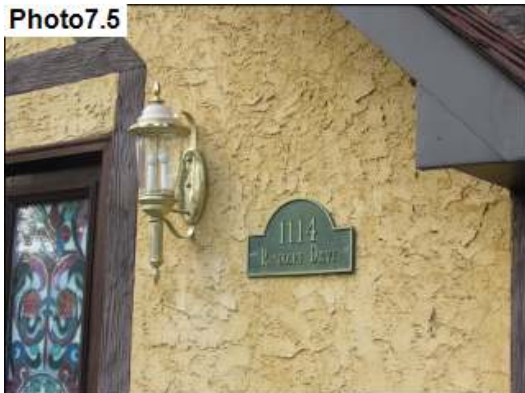
Photo7.5

Unsealed penetrations. All penetrations should be properly sealed.

2. Apply a low modulus sealant into bond breaking joints and transitions and all penetrations. A Dow Corning 790 or similar material should be used. Also, remove down spouts and shutters and apply sealant to the fastening systems, prior to their re-attachment.

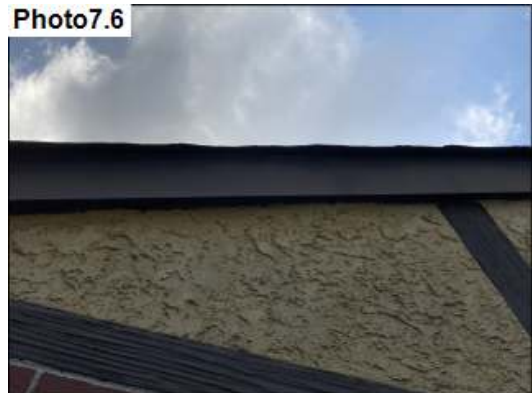
Photo7.6

7. Soffit/Fascia/Rake Intersections - The stucco intersection with soffit and fascia/rake board was not adequately sealed. Stucco industry details require fascia/rake boards to lap over stucco a minimum 1". If stucco is abutted to fascia/rake it should be sealed to prevent moisture intrusion due to wind-driven rain this is especially important in areas where there is a Gable "A" design. Any area or wall that is peaked is more susceptible to moisture infiltration without the proper details.

Sealant joint should be installed at intersection of stucco and rake board.

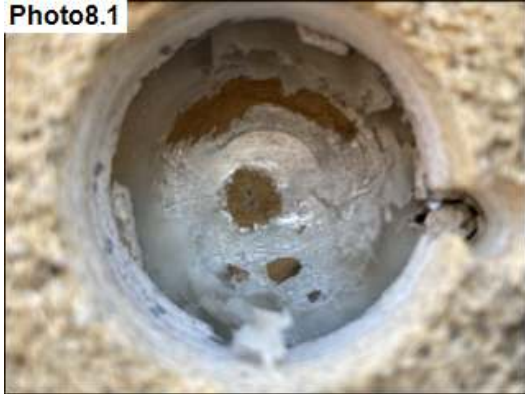
Photo8.1

Core revealed T-ply substrate over dry wood framing.
