Bats Foundation Repair

Subject: Assumption of Engineer of Record Letter  
Project Address: 7002 Teaberry Dr., Austin, TX  
Property Legal Description:

Subject: Post-Repair Foundation Repair Evaluation  
Slab Foundation  
7002 Teaberry Dr., Austin, TX

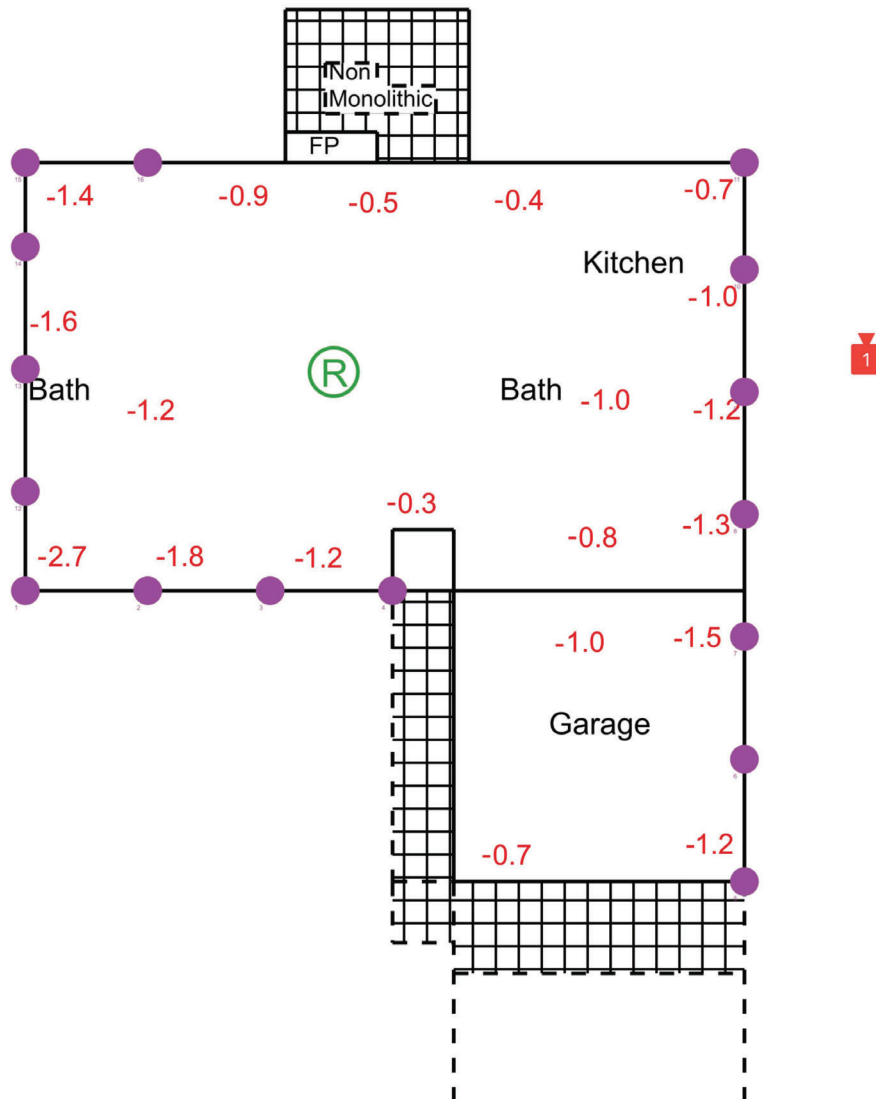
7002 TEABERRY DR., AUSTIN, TX

THIS DRAWING IS PROVIDED FOR PRELIMINARY PERMITTING PURPOSES ONLY AND IS A LIMITED PLAN OF REPAIR. ADDITIONAL WORK MAY BE NEEDED ONCE THE FOUNDATION WORK HAS BEGUN BASED ON THE PERFORMANCE OF THIS LIMITED PLAN OF REPAIR. CROSTOWN ENGINEERING HAS PROVIDED REVIEW OF THIS LIMITED PLAN OF REPAIR AND IT IS OUR OPINION THAT IT IS REASONABLE AND SAFE FOR THE STRUCTURE. IF INTERIOR PIERS ARE SHOWN ON THIS DRAWING THE CONTRACTOR WILL PLACE THEM BASED ON THE LOCATIONS OF GRADE BEAMS, PLUMBING LINES AND POST TENSION CABLES, THEREFORE, THE LOCATIONS SHOWN ON THIS MAP ARE APPROXIMATE. THE CONTRACTOR SHALL PROVIDE THE MEANS-AND-METHODS OF THIS INSTALLATION. ADDITIONAL REPAIRS MAY BE REQUIRED UPON REVIEW OF THE STRUCTURE BY CROSTOWN ENGINEERING. THIS IS A PROPOSED SCOPE OF WORK AND HAS NOT BEEN COMPLETED THEREFORE WE DO NOT CERTIFY ANY EXISTING OR PROPOSED FOUNDATION REPAIR WORK ON THIS MAP AT THIS TIME. IF THE READER WOULD LIKE TO BE CERTAIN THAT ANY PROPOSED OR EXISTING REPAIRS HAVE BEEN COMPLETED THEY MUST REQUEST AN ENGINEERING CERTIFICATE FOR THE SUBJECT FOUNDATION WORK FROM THE FOUNDATION REPAIR COMPANY.

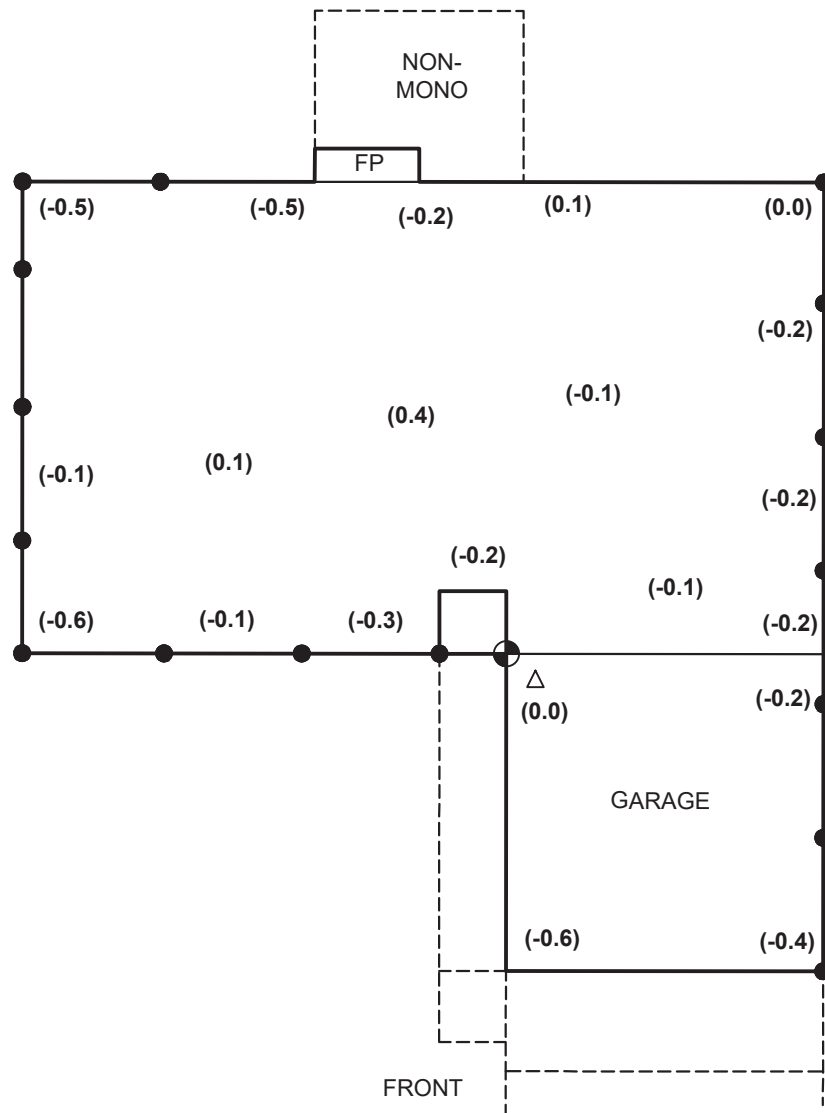
#### LIMITED REPAIR PLAN

Based on our observations and review of the limited repair plan provided by the contractor, the structure has experienced general foundation movement over the life of the structure, resulting in the front, left, back-left and right of the structure being low with respect to the rest of the structure. Drywall cracks and trim separations were observed.

- INSTALLED 16 TOTAL EXTERIOR PILINGS.

- Installed 16 total exterior pilings.
- The piers were driven to an average depth of 7'.
